DEPARTMENT OF TRANSPORTATION

Contract #: 04-0120F4Cty: SF/ALA Rte: 80 PM: 13.2/13.9File #: 69.28**WELDING INSPECTION REPORT****Resident Engineer:** Pursell, Gary**Address:** 333 Burma Road**City:** Oakland, CA 94607**Report No:** WIR-001604**Date Inspected:** 20-Feb-2008**Project Name:** SAS Superstructure**OSM Arrival Time:** 800**Prime Contractor:** American Bridge/Fluor Enterprises, a JV**OSM Departure Time:** 1730**Contractor:** Zhenhua Port Machinery Company, Ltd (ZPMC), Changxing Island **Location:** Shanghai, China**CWI Name:** Cui Yi Ru**CWI Present:** Yes No**Inspected CWI report:** Yes No N/A**Rod Oven in Use:** Yes No N/A**Electrode to specification:** Yes No N/A**Weld Procedures Followed:** Yes No N/A**Qualified Welders:** Yes No N/A**Verified Joint Fit-up:** Yes No N/A**Approved Drawings:** Yes No N/A**Approved WPS:** Yes No N/A**Delayed / Cancelled:** Yes No N/A**Bridge No:** 34-0006**Component:** OBG**Summary of Items Observed:**

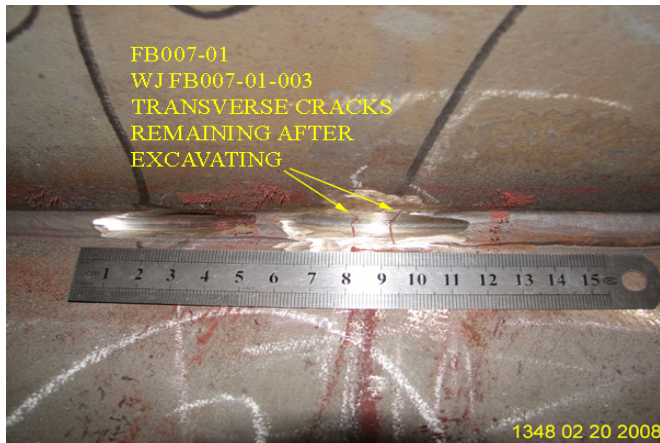
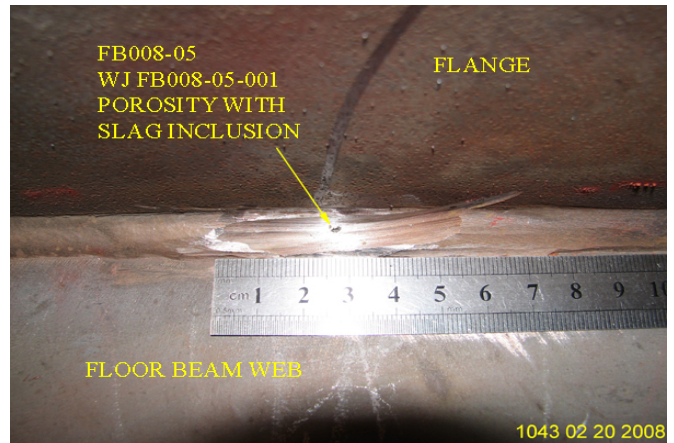
The QA Inspector performed Magnetic Particle Testing (MT) on excavations in flange to Floor Beam Web Weld Joint (WJ) Numbers FB008-06-001 (1ea), FB008-03-009 (1ea), FB007-06-009 (1ea), FB007-06-009 (1ea), FB016-02-003 (3ea) and FB007-01-003 (1ea). The excavation of the welds was performed to remove transverse cracks observed during Magnetic Particle Testing performed by ZPMC QC Personnel. The QA Inspector observed 1 indication visually in WJ FB008-06-001 that had actually been partially obscured by the grinding. A transverse crack had been removed but there was a single porosity pore underneath with slag in the pore. ZPMC personnel removed the indication with a die grinder, and all excavations appeared to comply with contract requirements. The attached photographs provide additional detail.
